A Galling Subject

The PT 11 Nesting Dinghy Connective system is unique and it makes up a decent portion of the cost of the kit. After roughly 200 PT 11's sold to date, there have been very few issues with this connective system. In this article we are aiming to share some lessons learned about these parts based on customer feedback and experience.

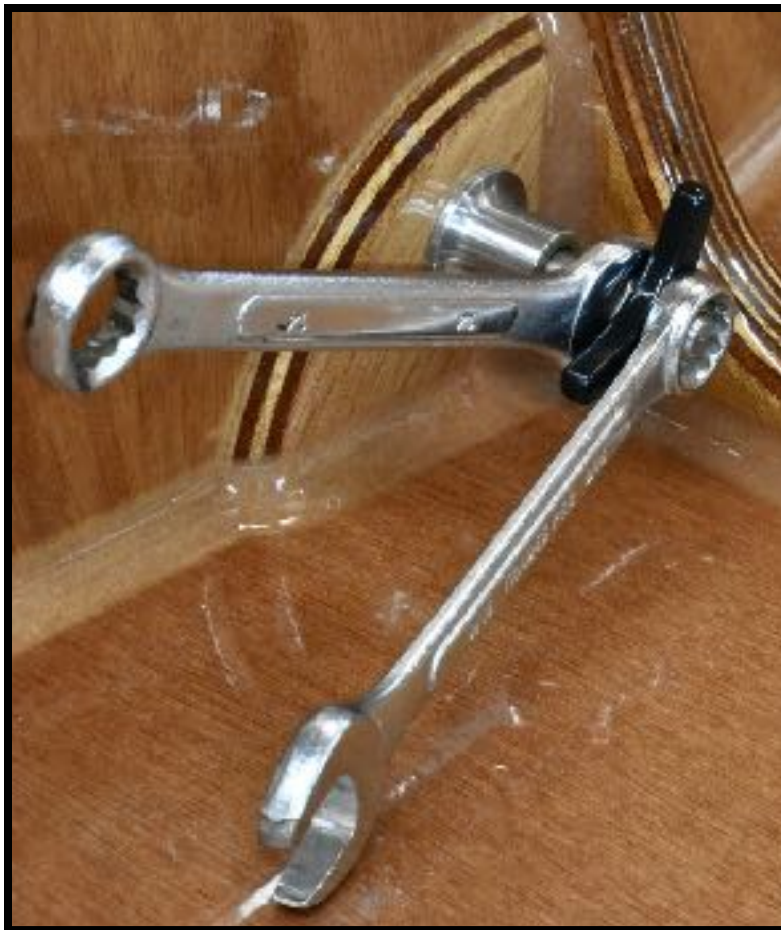
If a pin feels stuck, remove the knob using two wrenches; 14mm and/or 9/16" to remove the knob, nuts and washer.

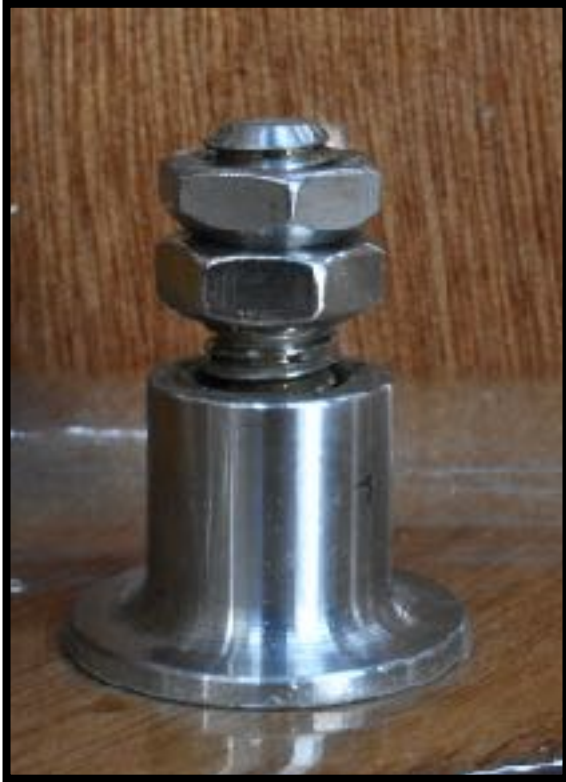
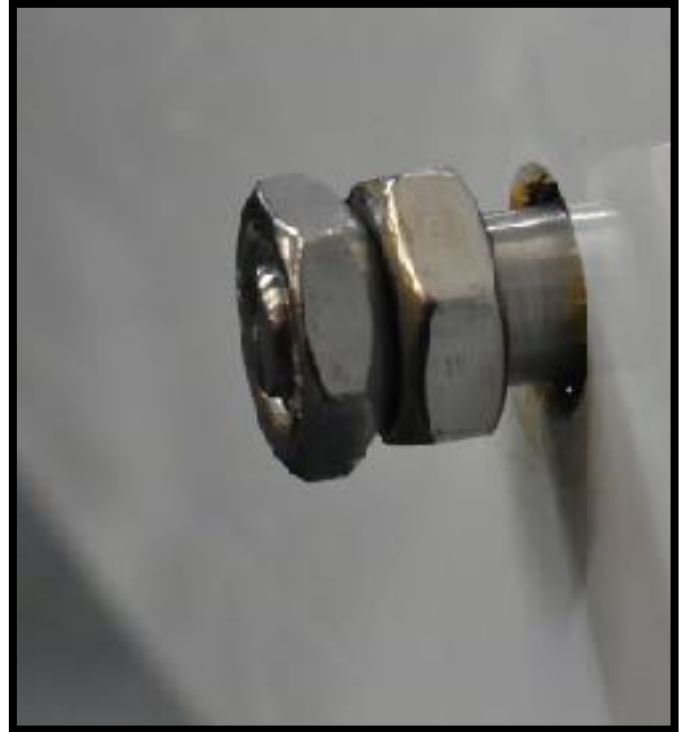
Put two nuts together on either end of the pin and tighten them together very tightly with the wrenches. (photos below)

Stand the hull half on end so that a bit of penetrating oil can be applied and run down into the socket. Now try tapping and banging on either end with a hammer and

wrenching on the end with the double nuts. Remember that the pin can only be removed from the socket in the forward direction because of the captive pin clip.

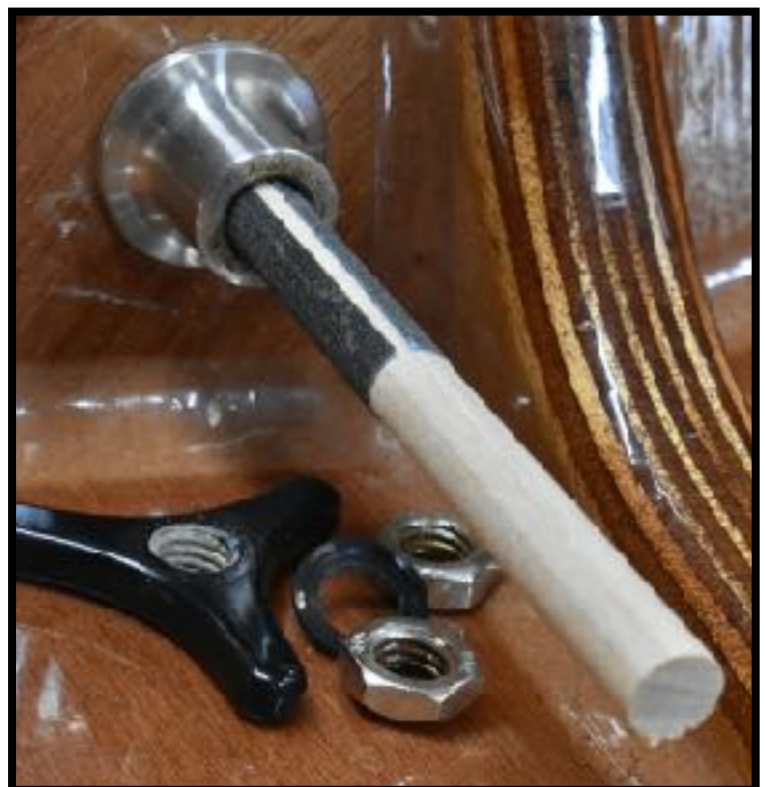
Take a short piece of 3/8" dowel, chuck one end up in your drill, wrap sandpaper around the other end, hit the trigger and sand the dowel down until it fits loose enough in the socket that you can wrap some fine (400 or finer grit) sandpaper around the dowel and have it just barely fit in the socket. The sandpaper can be spray glued and rolled tightly on the dowel before using it to sand away any and all burrs and roughness. Finishing with an even finer

paper is probably a good idea.

Spray-glue a bit of sandpaper to a flat stick to remove burrs from the pin before cleaning, applying the never-seize, and re-assembling the hardware.
